PROPOSED ROADSIDE WORK
ALONG BURKETT ROAD

Roadwork keyed to Map of Burkett (November 14th 2022)

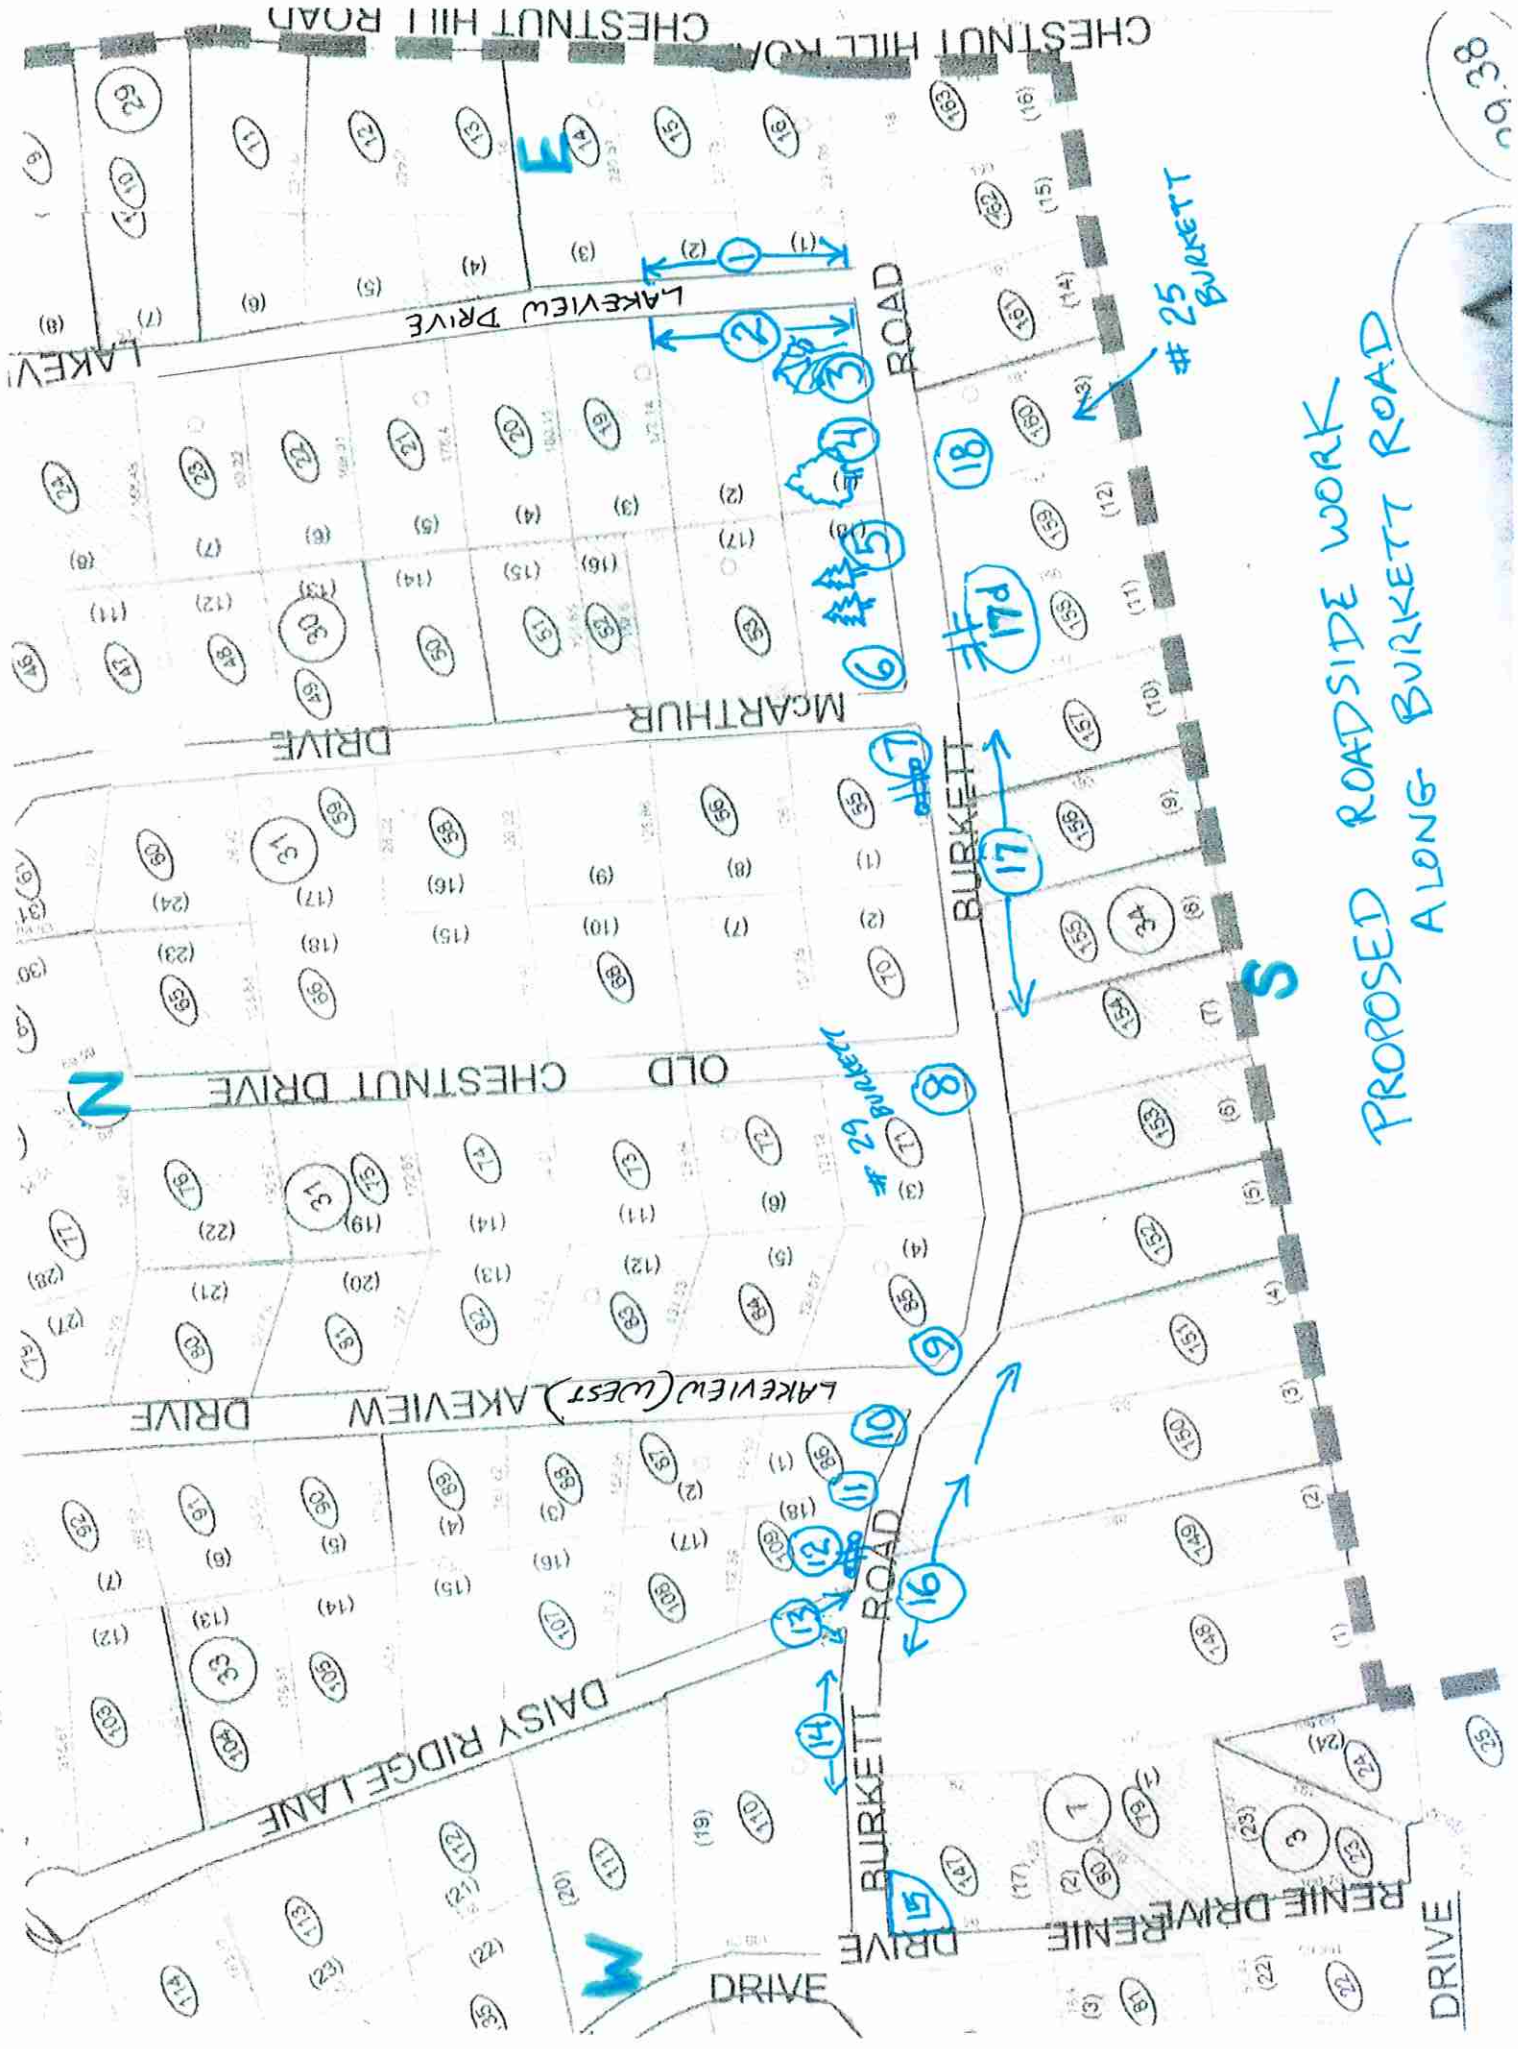
1. **East side of Lakeview Road from crest sloping down to Burkett.** **Decisions needed** –
 - a) Cut brush back about 5 ft from road's edge?
 - b) Cut roadside ditch or swale?
 - c) Widen road down hillside leading to 90° curve?
[Recommendation – on the principle of taking advantage of mobilized equipment, it makes sense to proceed with roadside work on this section. Once road surface has been repaired so that full width of road can be used by traffic, we suggest widening the road further will not be necessary.]

2. **West side of Lakeview Road from crest sloping down to Burkett.** **Decision needed** –
 - a) Clear roadside brush back about 5 ft from road's edge?
 - b) Cut roadside ditch or swale?
[Recommendation – same as previous point: proceed with roadside work on this section.]

3. **Northwest (inside) corner of 90° curve at Lakeview and Burkett** –
 - a) Work has been completed: brush cleared extensively (Cost: \$1400 – priced per job)
 - b) Remove large tree at corner? (Cost: flat rate - \$300)
[Recommendation – Keep the tree. During poor visibility and after dark, the tree provides a marker where the sharp turn is and also helps indicate the steep roadside drop-off. Perhaps we should even add reflectors to the trunk and at a location or two along the road's edge?]

4. **North roadside of Burkett shortly past 90° curve** –
 - a) Roadside berm built up from snow plowing creates a 'dam' holding runoff along edge of road. K&E was directed to employ skid steer to flatten berm and create sluice to catch runoff coming down hill and direct it over hillside. (Cost: not invoiced yet.)

5. **Burkett hillside (along north side) between 90° curve and McArthur Drive** —
 - a) Along portion of hillside, cut brambles and branches back about 5 ft. from road's edge.
 - b) To allow widening road, Lee suggested removing large roadside cedar. There's room along opposite (south) side to widen road if needed, so removing the tree judged not necessary.
 - c) Similarly, even if road is widened, removing two additional evergreens seen as unnecessary.
 - d) After cutting back growth along that roadside, drainage swale needs to be reinforced or cut.

6. **Northeast corner of McArthur Drive and Burkett intersection—**
 - a) Relocate road sign by a few feet to make room to improve drainage and re-position sign to discourage vehicles from cutting too close to corner of road.
 - b) Cut roadside drainage swale along east edge of McArthur from corner at Burkett and point +/- 20 ft. from the corner.
 - c) Behind previous signpost location, scrape low embankment down to catch runoff and direct it to drainage swale at corner where water will continue along hillside down Burkett.

7. **Northwest corner of McArthur Drive and Burkett intersection —**
 - a) Lee recommends scraping down slightly raised corner of yard back as far as behind water valve casing (casing would need to be trimmed down). **Recommendation – redefine corner more narrowly, cutting crescent in front of casing to direct water toward culvert (to be installed) under driveway.**

- b) At this address, the driveway directly onto Burkett appears to be an additional one installed by the residents, but has no culvert. **Recommendation – Install +/- 20 ft. culvert pipe under driveway.** (Cost: time + machinery + materials. 10 to 11 tons estimated amount of stone needed for culvert installation.) We'll need to talk with residents about proposal to transplant young trees positioned where each end of culvert would be located.
N.B. - elsewhere along Burkett all the way to Renie, culverts have been found at each location where needed, but many have to be unburied, restored or cleared of debris.

8. **Northwest corner of Old Chestnut Road and Burkett intersection —**
 - a) Recent work at both ends of the culvert under Old Chestnut improved flow to and from the culvert. But follow-up roadwork is needed to prevent water running down center of Old Chestnut, bypassing the drainage ditch and cutting a channel across Burkett.
Recommendation – (subject to revision by those more knowledgeable) to improve pitch of road: starting about 50 ft. from corner with Burkett, scrape down west edge of Old Chestnut and use scraped material to crown road. Along same side and length—about 50 ft—cut swale to channel water alongside Old Chestnut down to the corner into the ditch at outlet end of culvert. After work is complete, seed the swale. (Cost: time + machinery + material)

9. **Northeast corner of Lakeview (west) Drive and Burkett intersection —**
 - a) Restore flow to inlet side of culvert under Lakeview (west) Drive by clearing or re-ditching as necessary.
 - b) If culvert pipe is compacted, blow out silt/debris by working with fire company or renting a jet pump tank unit. (Rental cost = \$209/day; in response to an inquiry, Chief Cogle has indicated willingness to help blow out culverts. He still needs to be reached to discuss.)

10. **Northwest corner of Lakeview (west) Drive and Burkett intersection —**
 - c) Outlet end of culvert under Lakeview (west) Drive is buried; needs to be dug out.
 - a) At slope where Lakeview (west) meets Burkett, runoff needs to be caught and channeled into ditch at outlet end of culvert under Lakeview. **Recommendation – on northwest side of Lakeview (west) Drive, cut ditch or swale starting about 20 ft. up slope.**

11. **Within easement along north side of Burkett Road—**
 - a) Well-defined ditch line is present, but sod should be cut intermittently to restore good flow.

12. **Culvert under #222 Burkett private driveway —**
 - a) Both ends of culvert need to be cleared. Inner debris may need to be cleared.

13. **Concrete culvert under Daisy Ridge Lane —**
 - a) Swale approaching culvert under Daisy Ridge Lane needs to be cut deeper to restore flow
 - b) Outlet end of culvert is buried - needs to be dug out. Inner debris may need to be cleared.

14. **North side of Burkett Road within easement beside lot (19)—**
 - b) Well-defined swale is present, but spots should be cut intermittently to restore good flow

16. **South roadside along Burkett Road —**
 - a) A well-defined drainage swale about 4 ft. from the road's edge has been discovered along the length of the south side of Burkett Road. Thick overgrown grass needs to be cut away, then when drainage configuration can be seen clearly, reinforce or re-ditch where necessary.
 - b) Decision needed – how much of that section of Burkett needs to be widened?

- a) Work complete: Weed-eating and cutting selected saplings revealed an extended drainage ditch about 4 ft. from the road's edge running along the south side of Burkett. (Cost: \$1200 hourly labor rate for three workers and crew lead).
- b) Now that it's visible, reinforce or re-ditch the drainage swale where needed. (Cost: time + labor + equipment).
- c) **Recommendation** — to maintain drainage flow, contract mowing/weed eating at least 3x/year and blow out ditches and culverts once autumn leaves are down.

- a) A culvert needed under this driveway has been discussed a few times. After clearing away the grass overgrowth, the already existing culvert was discovered! Silt/debris may need to be blown out of pipe to restore water flow (see #9 re. renting a jet pump tank unit or working with fire company to clean culvert).

- c) Lee suggested that McArthur Drive needs to be widened. **Recommendation – since it's not a thru road, it shouldn't be widened.**

15. **Southeast corner of Renie Drive and Burkett intersection —**
 - a) This is a vacant Oak Meadow lot. It's a spot recommended for temporary storage of stone needed for culvert installation (at McArthur/Burkett intersection, see #7 above) and if needed to build up Old Chestnut roadbed (see #8 above).

Recommendation – once road is leveled and repaired so traffic can use full width of road (already 18 ft. wide in many sections), probably few areas need to be widened. With no driveways for an extended length along the south side of Burkett (along #14 and #15 on map) the south side has room to widen road where needed. 18 ft. maximum width recommended, which allows traffic to pass smoothly but hopefully curtails overly excessive vehicle speed. Long term re-surfacing maintenance cost is also part of equation.

N.B. Discovery of this swale means a significant cost saving; otherwise, Lee had expected we'd have to cut a ditch the full length of Burkett along the south side.
